Old Ship Meeting House

Hingham, MA

Massachusetts Historical Commission
2015 Preservation Award Nomination
Rehabilitation and Restoration

**Old Ship Meeting House
Comprehensive Restoration
Hingham, Massachusetts**

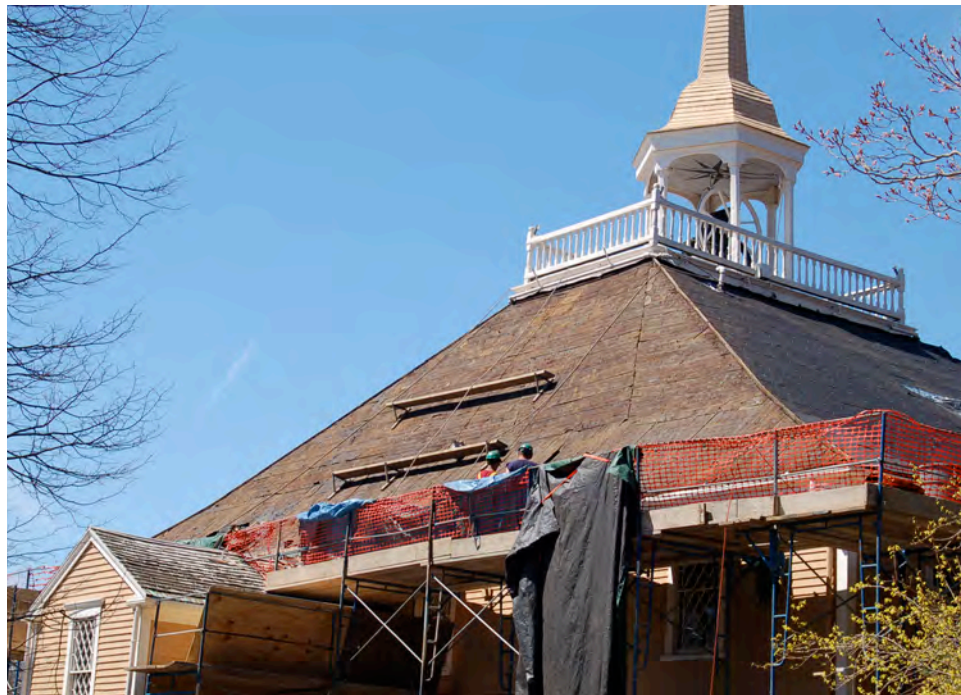
The roof was stripped of its existing shingles, which were nailed directly to the sheathing boards. The removal of the shingles revealed that the roof preserves most of its original sheathing boards. The pattern of these boards shows that the east and west 1681 roofs originally had roof gables and the changes in the roofs associated with the 1731 and 1755 additions. (The north and south roofs of the original meeting house have been covered over by the 1731 and 1755 additions, but surviving elements of their framing also indicate that they originally had gables. (Figures 2 – 4)

Figure 2. Old Ship Meeting House. East elevation – Wood shingle roof stripped, exposing historic sheathing boards.

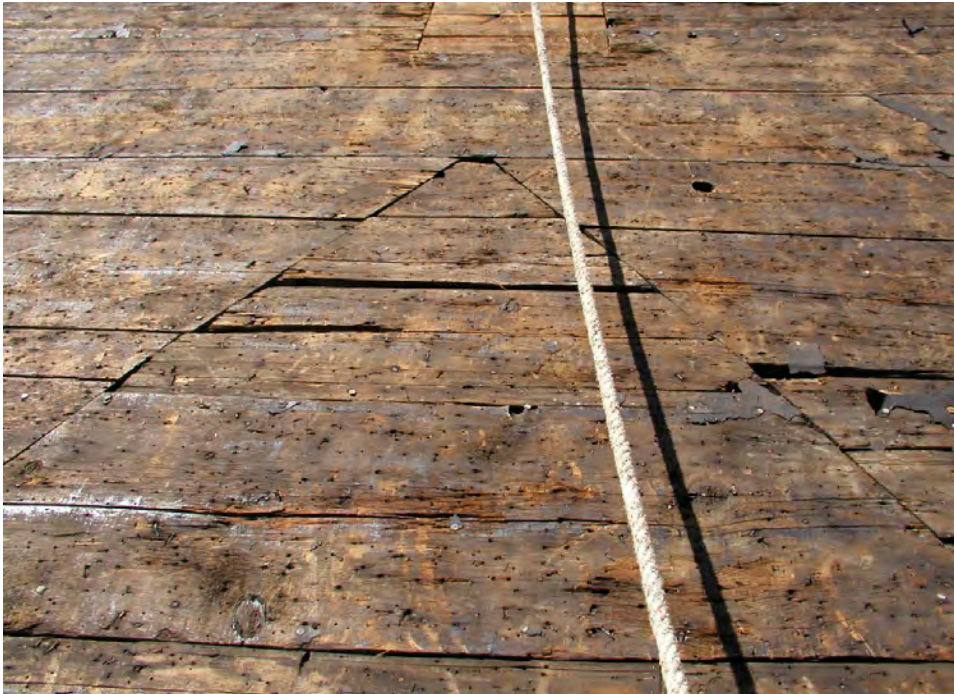
Figure 3. Old Ship Meeting House. East elevation – Patched roof sheathing boards identifying the location of the 1681 roof gable. Rectangular patch above is the former chimney location.

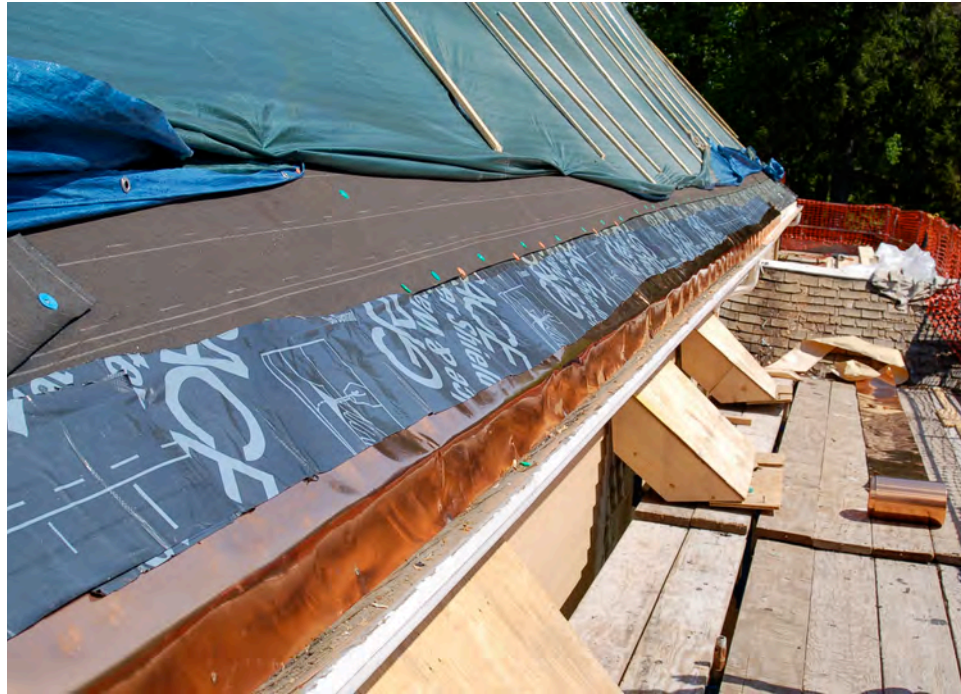
The condition of the sheathing boards was very fragile from years of nailing. To avoid any significant replacement of the sheathing boards and to provide a nailing surface for the new shingles, the roof was strapped. At the edges of the roof, the sheathing boards were covered with ice and water shield, and a new copper edge flashing installed. (Figures 5 – 6) The new wood shingles were hand-nailed to the strapping.

Figure 5. Old Ship Meeting House. East elevation – Installation of new ice and water shield at eave.

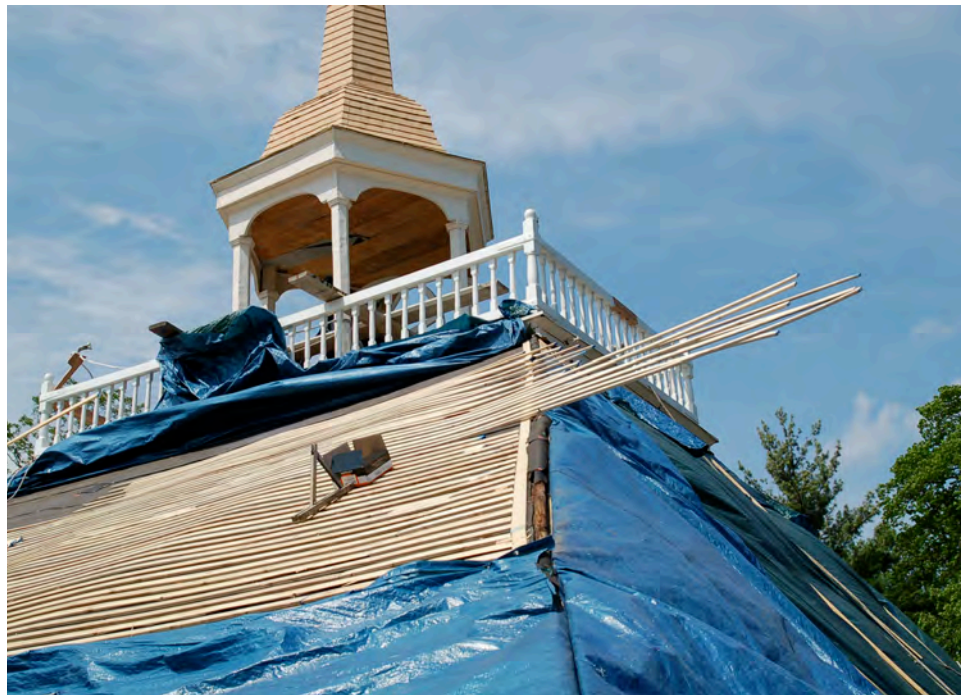
Figure 6. Old Ship Meeting House. South elevation – Installation of roof strapping.

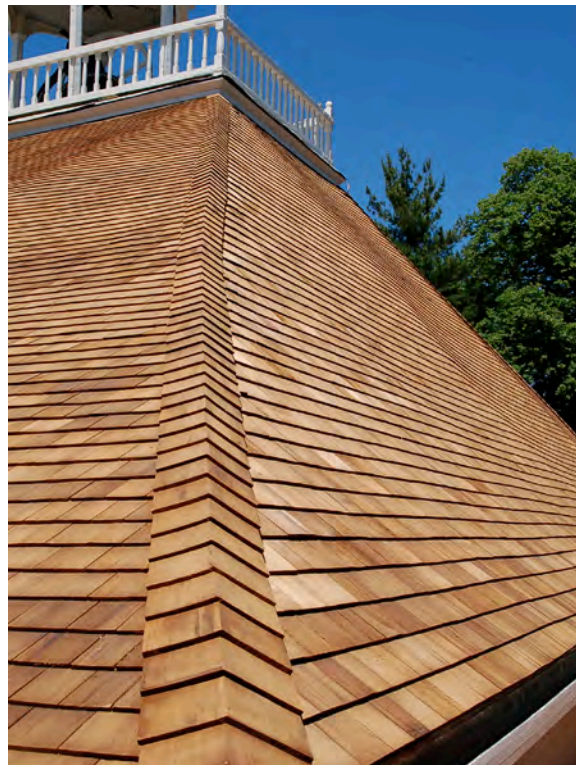
One change was made to the wood shingle roof. The exterior sprinkler system that had been installed on the roof hips in the 1930s was not reinstalled. It had not been functional for years and with modern fire-fighting equipment, it was no longer deemed necessary. (The sprinkler had been installed to prevent the roof from catching fire from flying embers from nearby building fires.) The hips were finished with woven wood shingles. (Figures 7 – 8)

Figure 8. Old Ship Meeting House. Southeast corner of wood shingle roof showing woven hip.

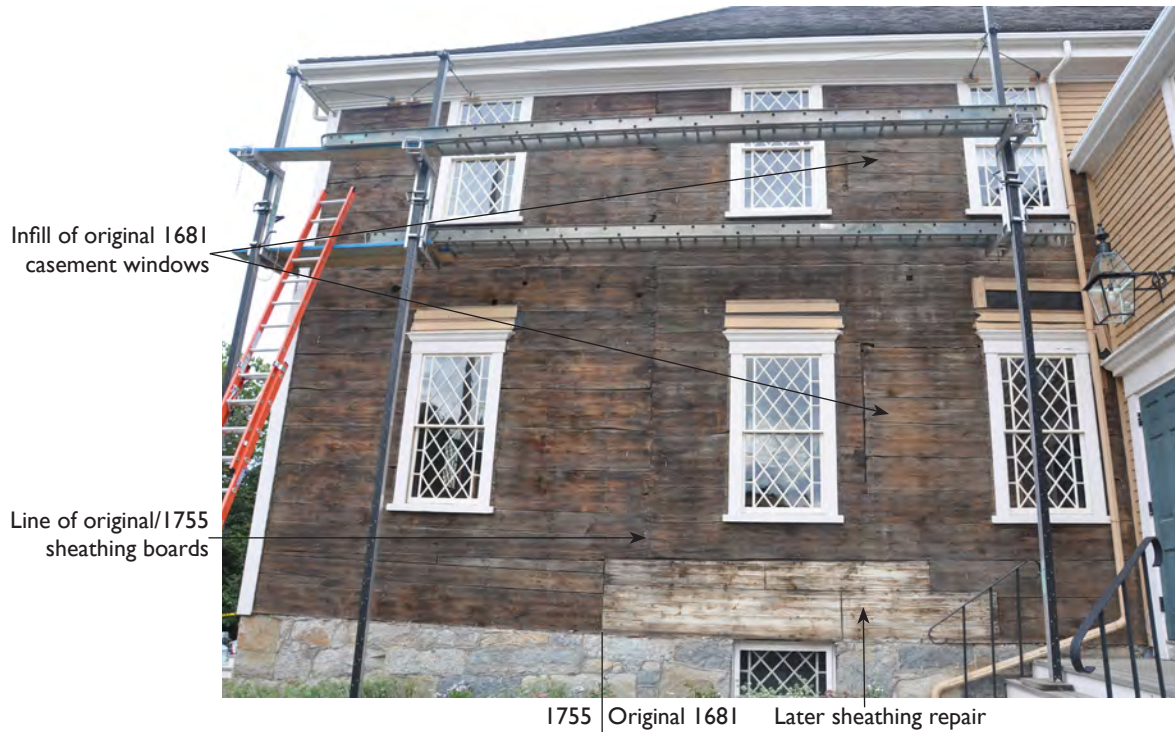
The major exterior carpentry repairs were concentrated on the east elevation of the building. Modern clapboards installed in the 1960s as well as some nineteenth century clapboards were replaced. A sill repair was also made at the location of the former brick entry steps.

As on the roof, the stripping of the modern clapboards from the east wall revealed, remarkably, that most of the sheathing boards are original. They document the 1731 and 1755 additions to the building, as well as the locations and size of the 1681 casement windows. (Figures 9 – 12) The casement windows were replaced in 1755 with double-hung, twelve-over-twelve sash. Prior to this work, the size and locations of the casement windows, though speculated, was not documented.

Figure 9. Old Ship Meeting House. Exterior carpentry repairs – East elevation – Modern clapboards removed and replaced. Note documentation of building history shown in sheathing boards.

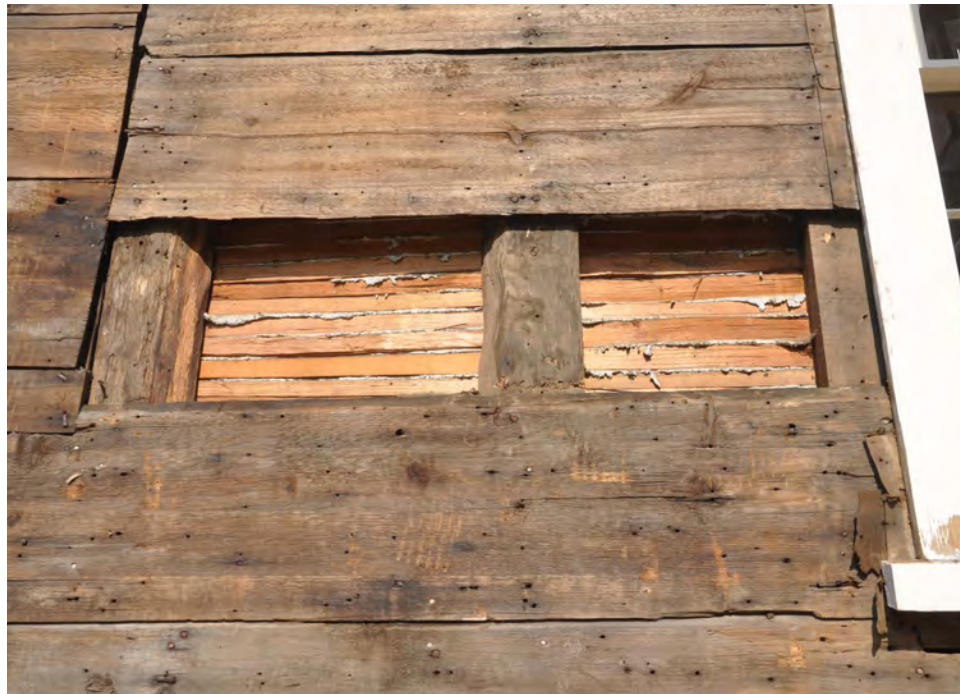
Figure 10. Old Ship Meeting House. East elevation – Detail of casement window (1681) infill. Windows were infilled in 1755.

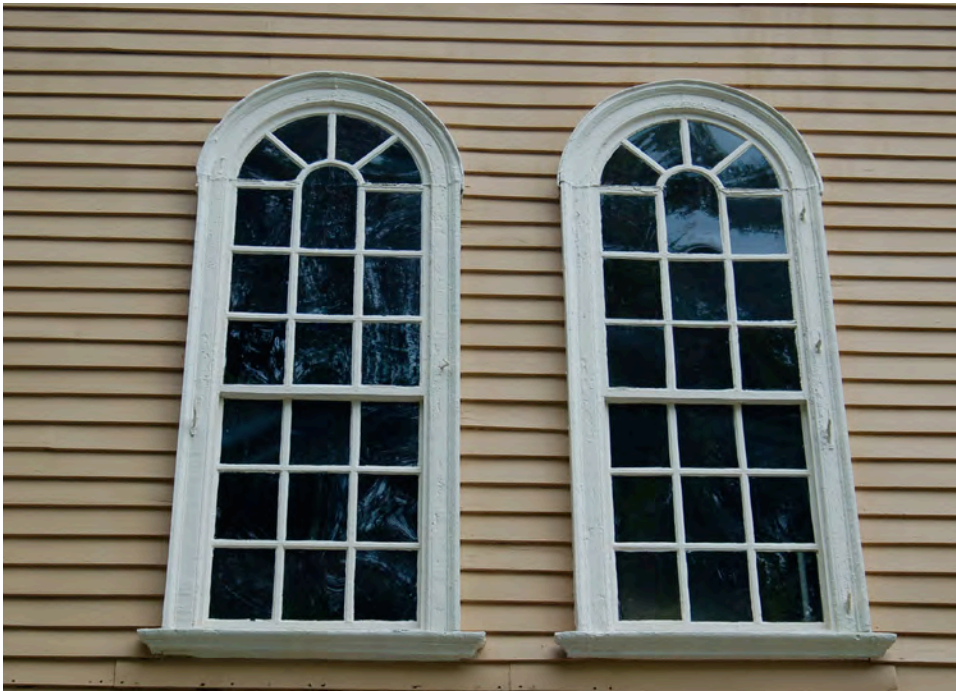
In addition to the diamond-paned windows, two of the 1755 windows survive at Old Ship. They are the arched-topped windows above the pulpit in the west wall. These windows required more extensive repair. Their glass was removed, wooden sash repaired, glass reinstalled with new putty and repainted. These windows also had an exterior Tru-View protective panel installed. (Figures 16 -23)

Figure 16. Old Ship Meeting House. West elevation – 1755 – Arch-topped windows behind pulpit, before restoration.

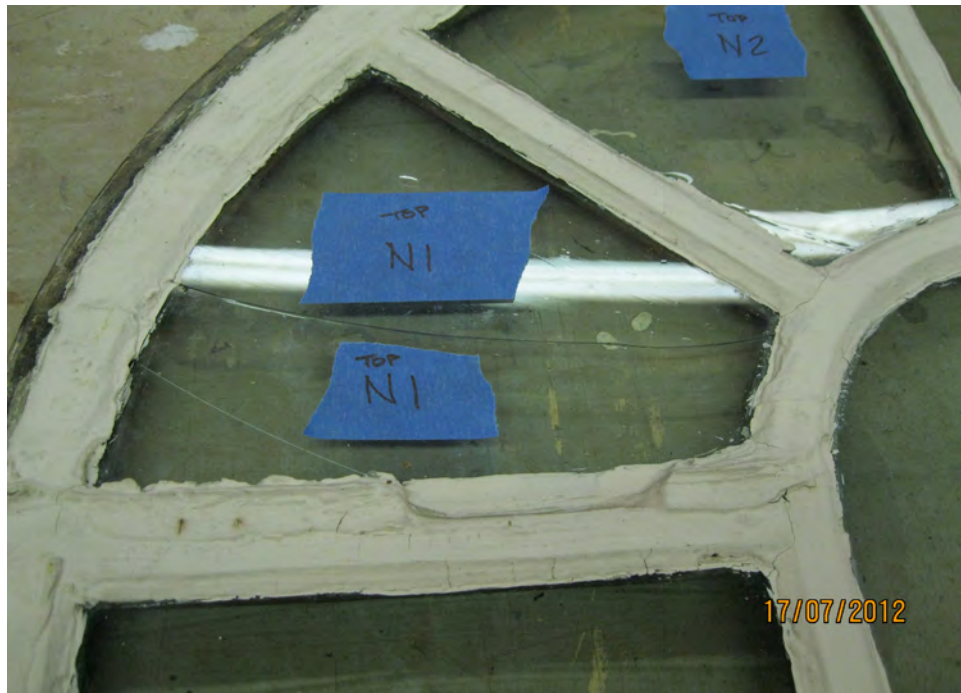
Figure 18. Old Ship Meeting House. 1755 sash – Detail of deteriorated glazing. Photo courtesy of David Webb.

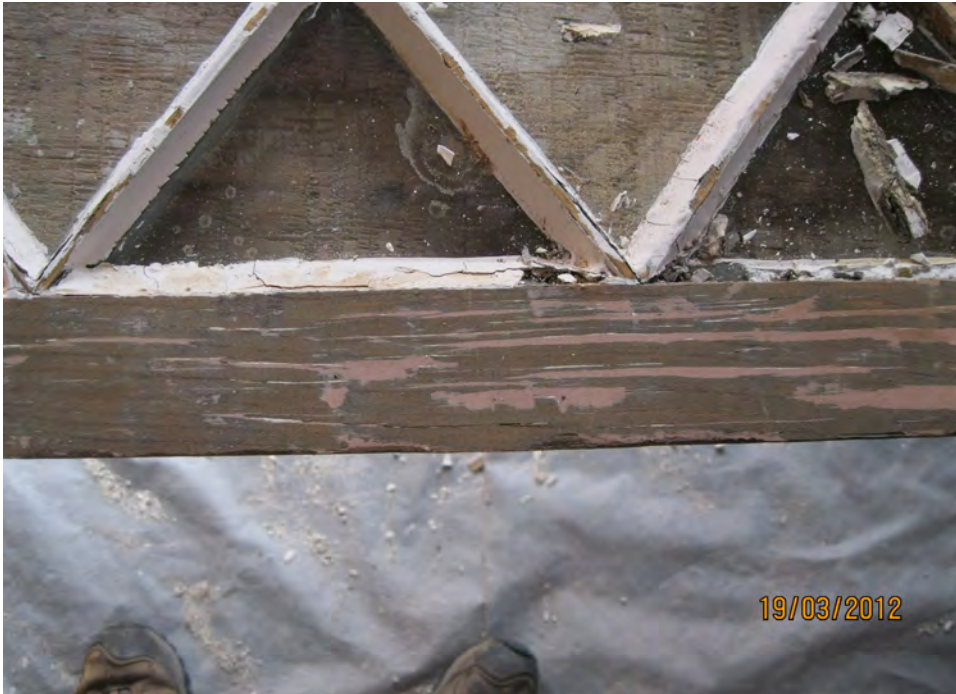
Figure 19. Old Ship Meeting House. 1869 sash – Detail of deteriorated glazing. Photo courtesy of David Webb.

The decision was made at the inception of this window restoration project that the glass would not be removed from the diamond-paned windows. The wood frames of the sash were generally in good condition and removing the glass would have caused significant breakage. The diamond-panes, with their narrow tips, are even more vulnerable to breakage than a rectangular piece of glass. All of the sashes were removed from their openings, any necessary carpentry repairs made, glazing putty replaced, and repainted.

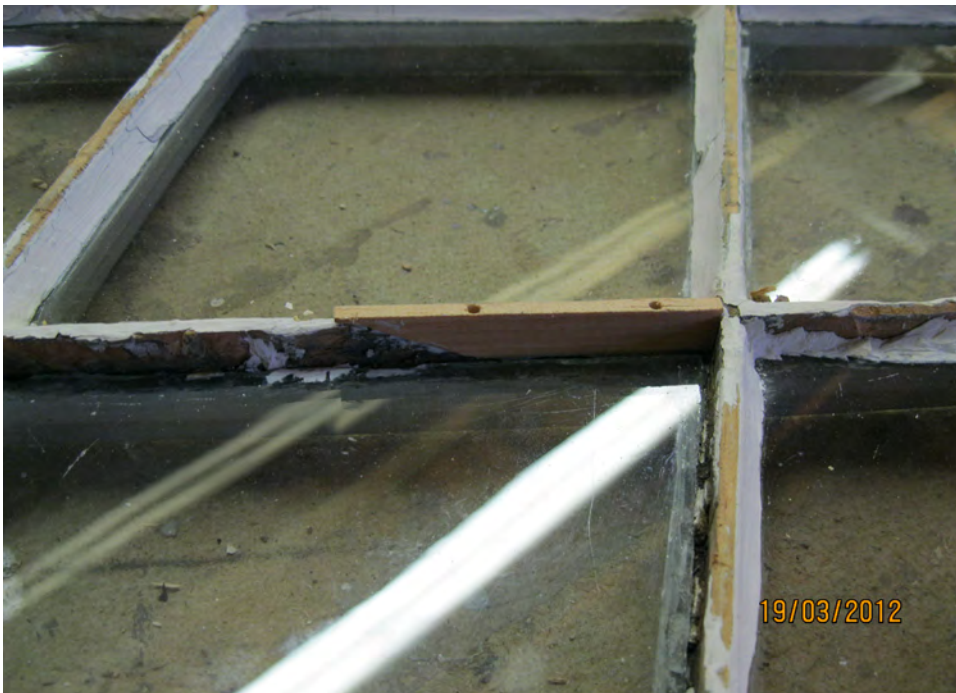
Figure 20. Old Ship Meeting House. Detail of muntin repair. Photo courtesy of David Webb.

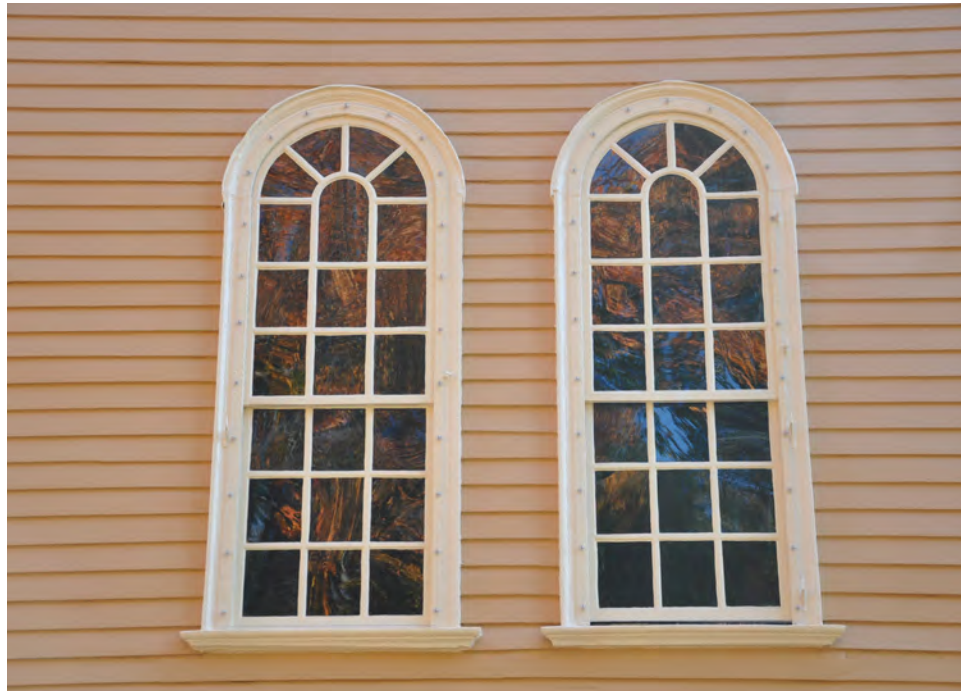
Figure 22. Old Ship Meeting House. West elevation – 1755 sash restored with new protective covers installed.

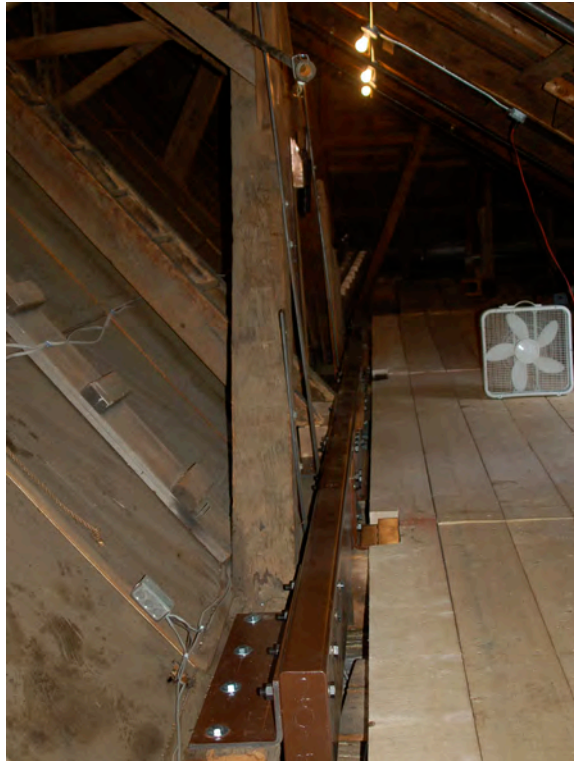
Old Ship Meeting House retains most of its original (1681) timber frame. The notable exceptions are found on the north and south walls, where much of the vertical framing was removed when the 1731 and 1755 additions were built. With the removal of the vertical framing members to open up the interior space in the Meeting House, the plates of the north and south wall had sagged and deflected. Earlier supplementation of the frame had included the installation of a timber strong-back at the west end of the north plate as well as the construction of pony trusses at the center bays of both the north and south walls.

Figure 31. Old Ship Meeting House. New structural steel installed on north side of attic. Steel supplements the deflected plates of the original 1681 timber frame.

The reinforcement of the timber frame was designed to be supplemental and to be completely hidden in the attic spaces above the beams requiring additional support. The supplemental steel was designed by Odeh Engineers and installed by Webb Preservation. The steel was lifted into the attic through the dormer windows. Wooden templates were made of each of the pieces of steel to assure that they could be installed in the space. Multiple pieces, rather than full-length, installations were required.

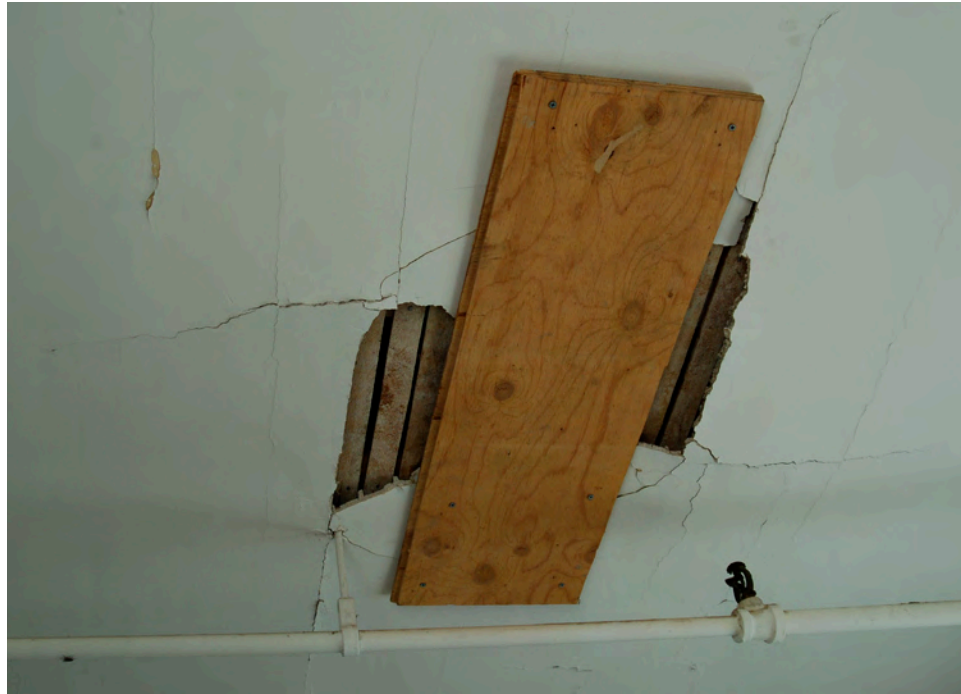
Most of the interior finishes restoration involved plaster repair – both areas of plaster loss and areas where the plaster had become detached from its wood lath substrate. (Figure 33) Extensive plaster consolidation was done to the galley ceilings. The lath of these ceilings is exposed in the north and south attics. (Figure 34)

Figure 33. Old Ship Meeting House. Plaster failure requiring re-adhesion and patching.

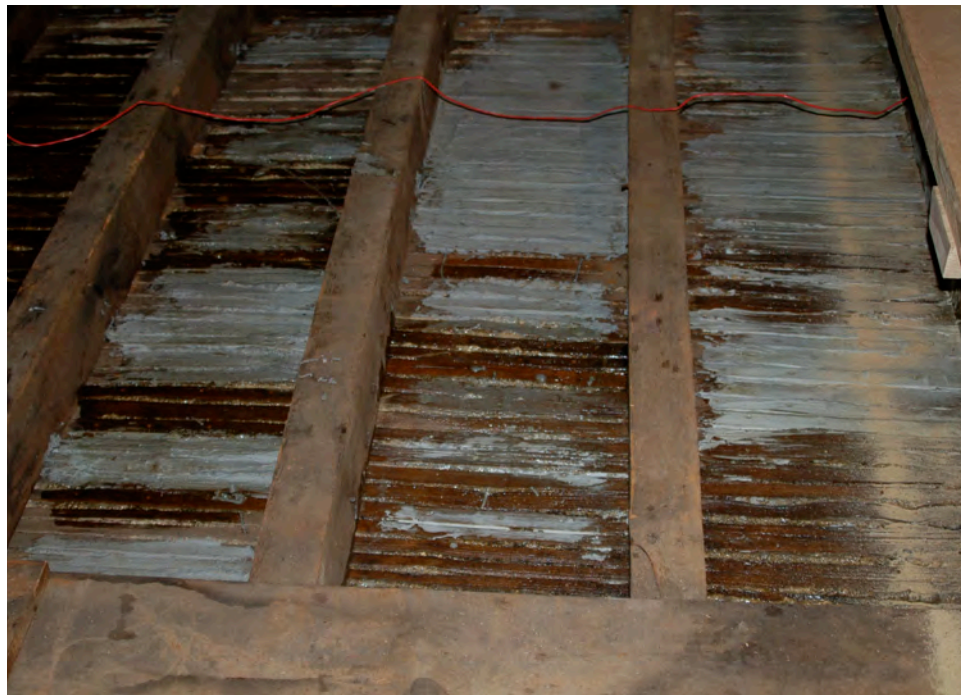
Figure 34. Old Ship Meeting House. Plaster re-adhesion.
